REPORT FOR: WENITA FOREST PRODUCTS LIMITED

DATE: 2ND APRIL 2014

SUBJECT: STREAM RESTORATION PROJECT

Paul Pope
Spiralis - Environmental Solutions Consultancy

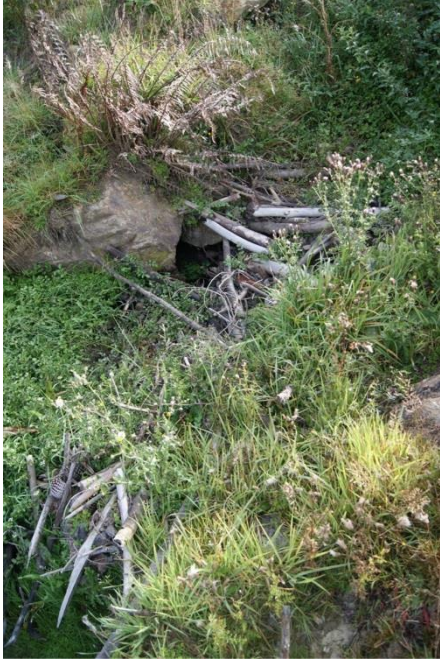
The water flow from the bottom section of the creek was very slow and it was noted that a culvert had blocked water in the area. Below the stream water flow was consistent with type and scale of the creek.

Figure One - The culvert on the south east end of the creek must be kept clear for water flow and any spawning activity of fish in the area.

The culvert at the south-east end of the site needs clearance and should remain clear at all times to ensure steady water flow.

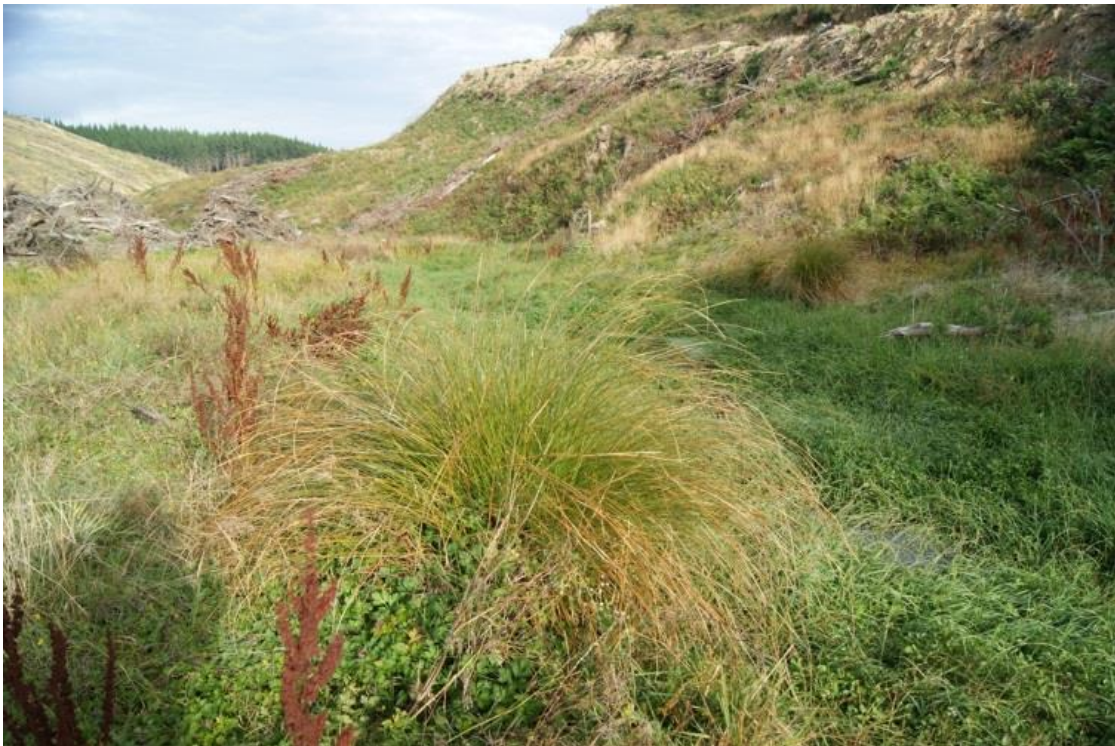
Predominantly the vegetation on both sides was a mix of exotic agricultural grasses, dock, gorse, fireweed, blackberry and thistle.

Figure Two - Overview of vegetation types in the south east end of the creek

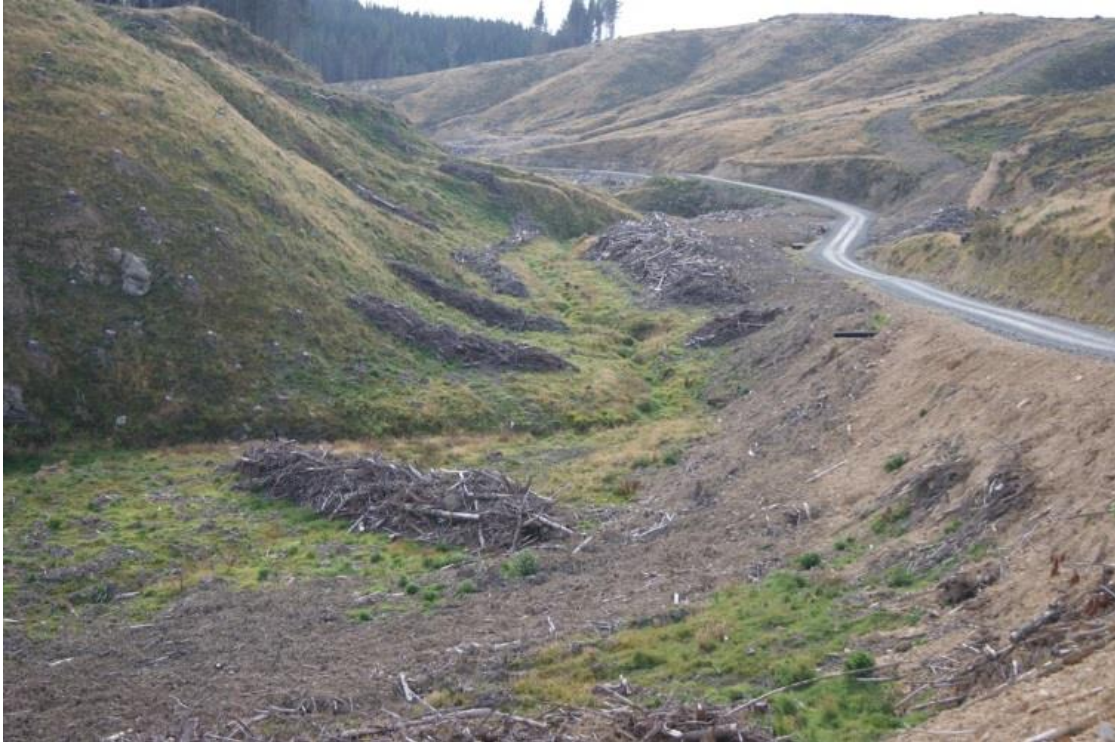
The surrounding vegetation has been production *Pinus radiata* and that has been felled in the last 18 months with remaining detritus wind-rowed as is the common practice. In discussion with Mike the creek has had logging detritus and material pushed back and away to ensure appropriate water flow.

Figure Three - Overview of creek position in relationship to the road, wind rowing and forest harvesting. Note the available width of the area.

The length of the area (1km) available resources and the topography will largely determine the width of the restoration planting. In general it is recommended that the total width of the revegetation area be 10 metres from the edge of the stream landwards on both the true left (5 metres) & right (5 metres). There is likely to be some variation because of the position of wind-rows and the topography where the site narrows in places. Flexibility in plant selection for these areas is required.

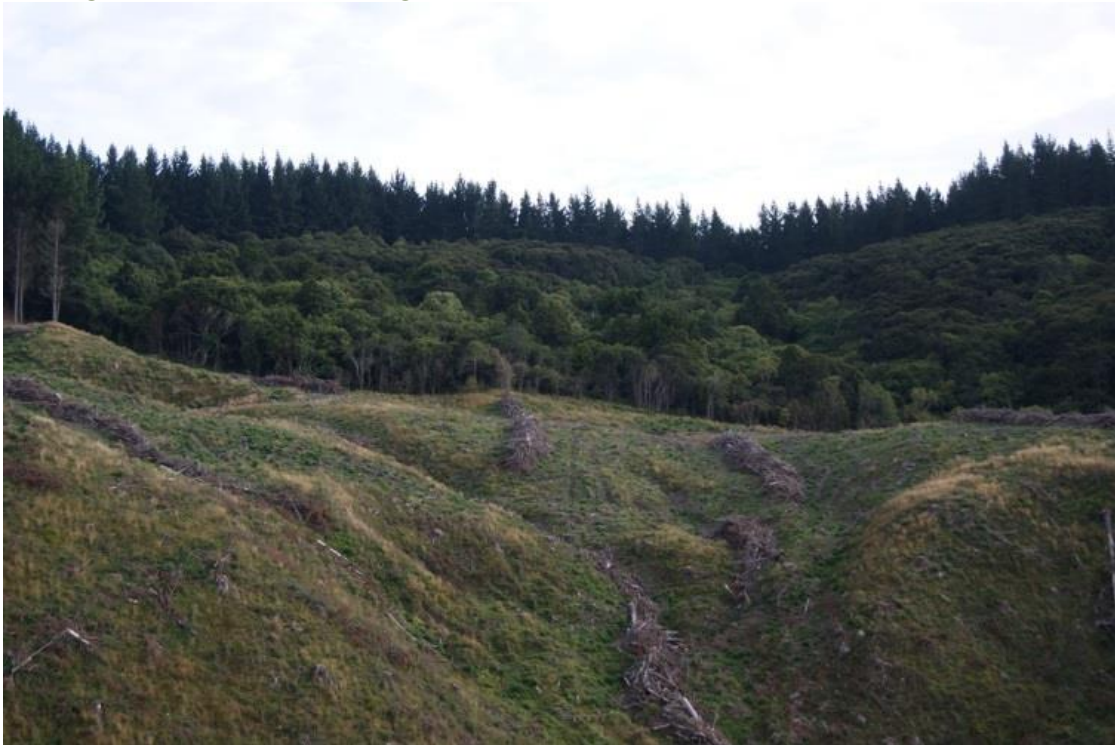
It was noted that the area lies below a significant section of emergent rimu forest and the presence of this forest will give an indication of the suitability of restorative species.

Figure Four - Podocarp remnant gives an indication of suitability of species for the revegetation area.

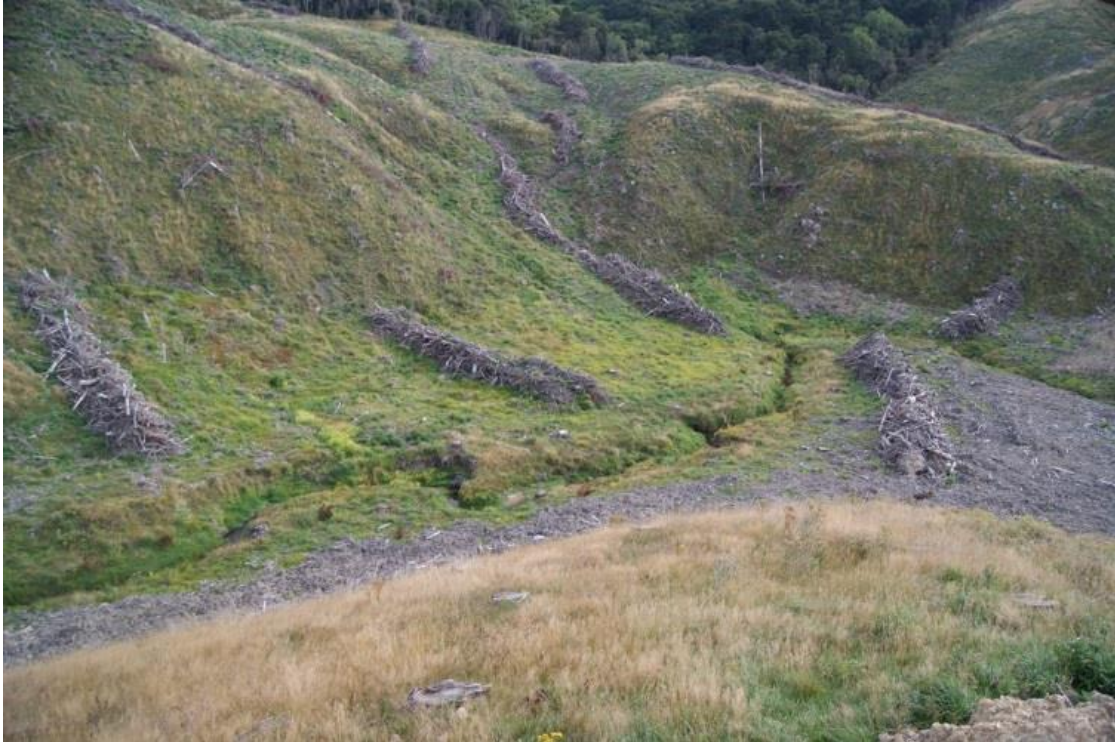
Figure Five - Central stream site showing availability of width in relation to wind rows and the natural creek terrace.

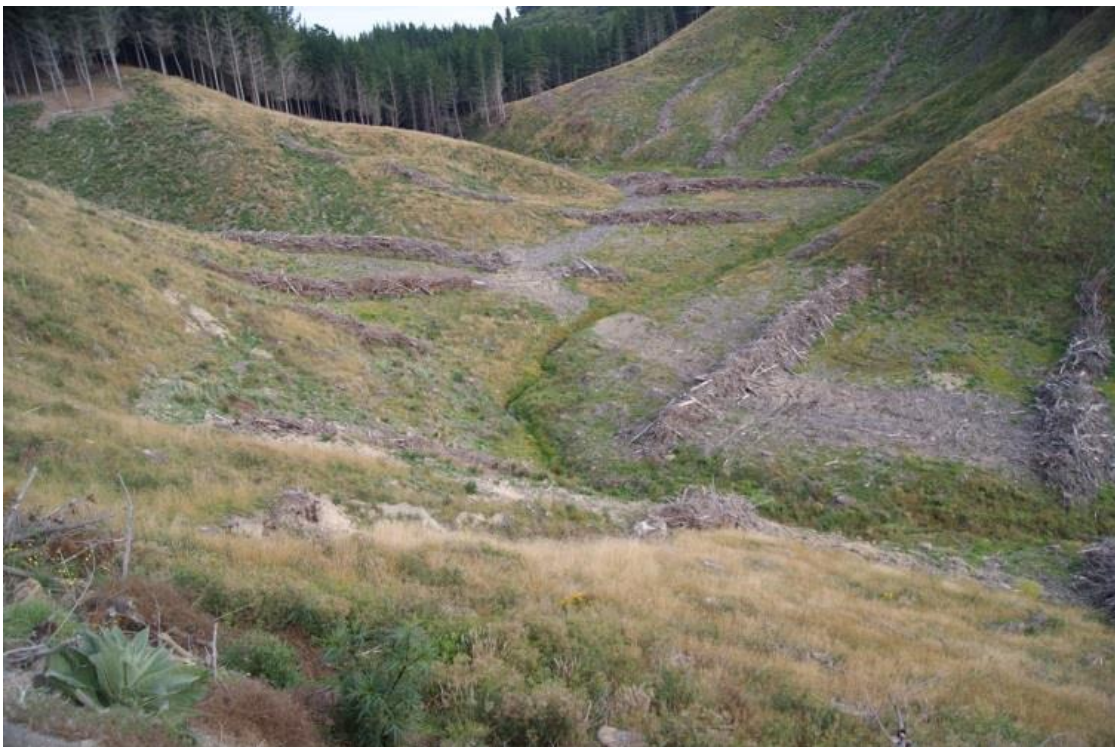
Figure Six - Upper section of the creek in the north west corner of the site.
