Native Vegetation Reserve Inspection Report

Client: Wenita Forest Products
Liaison Officer: James McEwan
Date: 3/7/2017
Site: McLaren Gully Road
Compartments: Compartment 43
Size: Not available
Criteria: 3 (Moderate-Above Average)

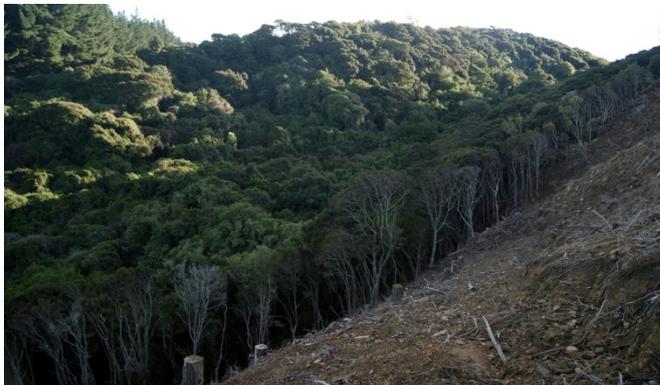
Figure 1 View of the western section of the compartment showing the comparison between kanuka and lowland broadleaf forest

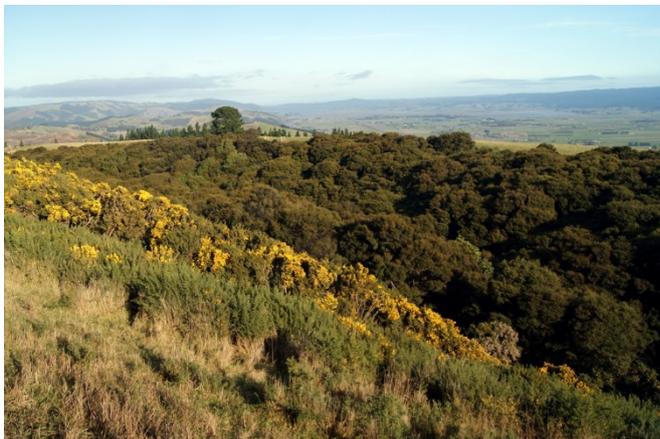
Gorse grew strongly on the fringes of the western section along with a number of mature and semi pines.

Figure 2 Kanuka section showing the new and older gorse growing on the perimeter of the compartment

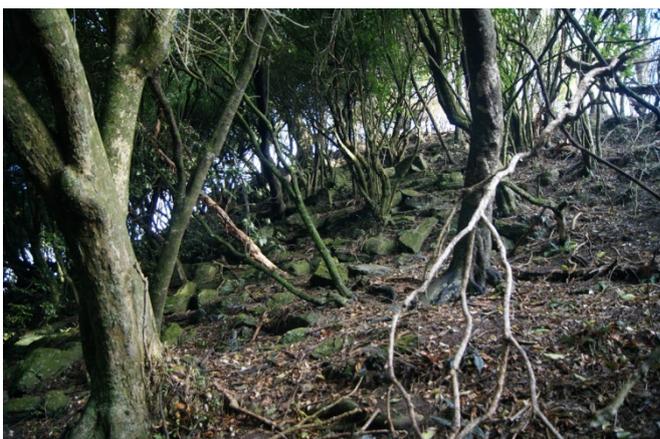
The forest floor was poor in many places due to browsing and the upper western site open to stock incursions from the nearby farm.

Figure 3 The understory of the compartment had been heavily browsed and was poor in places.
