SHMAK Monitoring Report – Winter 2014

The Stream Health Monitoring Assessment Kit (SHMAK) is used to assess long term trends in water quality within Wenita's estate. Monitoring should be undertaken twice yearly in late spring/early summer and then again in late autumn/early winter. But is requested to be done over winter this report refers to monitoring undertaken over a period from August to October 2014.

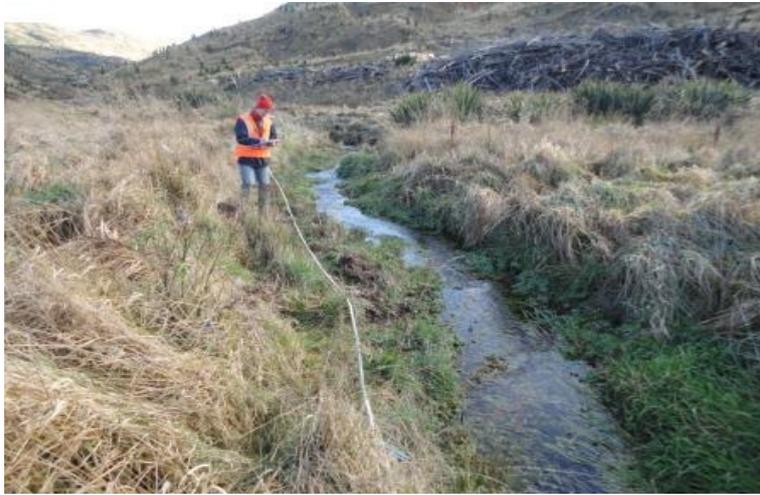
Site 1 – Mt Allan, Poplar Hut:

Result: Overall score: **Very good**

Summary: This year the Poplar site was located a bit further downstream from last year's SHMAK site. There wasn't a lot of change in terms of the surrounding vegetation and composition of the stream bed. However it was noted there was more of a presence of stream vegetation in the water itself. Last year score was Moderate a reason for the improved score this year was as years pass less disturbance from harvesting, resulted in more improvement in water quality and vegetation growth has improved the score.

Conclusion: Further Monitoring

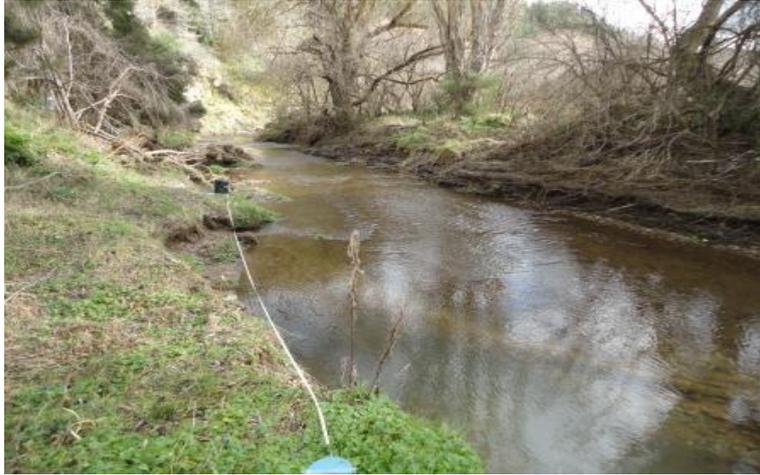
Site 2 –Mt Allan Big Stream:

Result: Overall score: **Good**

Summary: This year's SHMAK site at Big stream was moved further upstream from last year the reason being that there had been earthworks to clear out the silt and improve the flood protection so this may have affected the result of the SHMAK survey. Again not much change to the surrounding vegetation and composition of the stream bed from last year. Last year's score was Good again and factors again relation to less disturbance from harvesting shading from the willow trees and increased growth from bank vegetation. Invertebrate numbers from this year showed no major changes to last year.

Conclusion: Recommend further monitoring

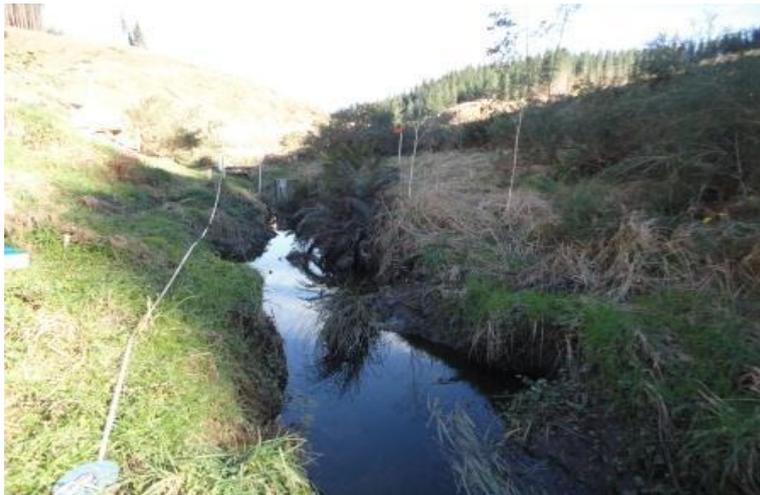
Site 3 – Hopehill, Otokia Stream:

Result: Overall score: **Very good**

Summary: The Hopehill site on the Otokia stream was a different contrast this year. Harvesting along the SHMAK site this year has resulted in a more exposed site and also noted increase in slash and debris in the stream. What was also noted was a lot of sediment movement from upstream. Water clarity was improved from the year before and an eel was seen present along the test site.

Conclusion: Recommend further monitoring
Second SHMAK site or move present site into native planting area

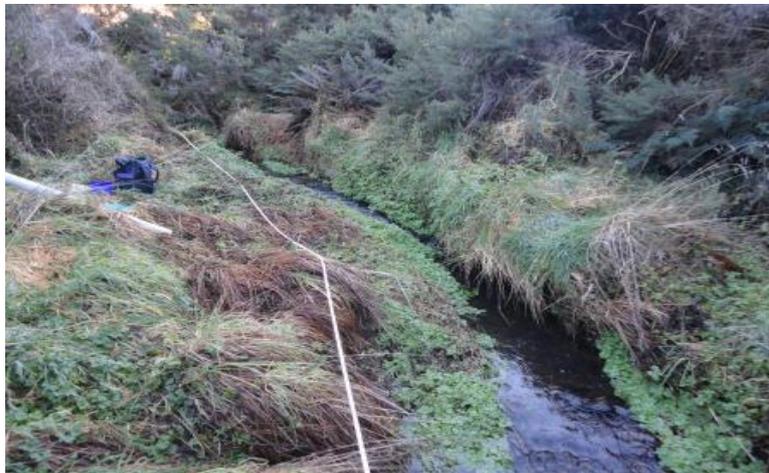
Site 4 – Akatore, Taieri Beach road:

Result: Overall score: **Good**

Summary: Taieri beach road site showed not much change compared to last year's site what was noted was the increased presence of water vegetation along the stream. Last year's score was Very poor all-round and there have been inconsistencies in terms of the result scores and testing methods. It has been suggested that the SHMAK site be moved as this site doesn't really represent the overall health of the stream but with a better result this year, suggest maybe to keep to the same site for next year and see what results come from that.

Conclusion: Recommend further monitoring
Keep same site for next year pending results

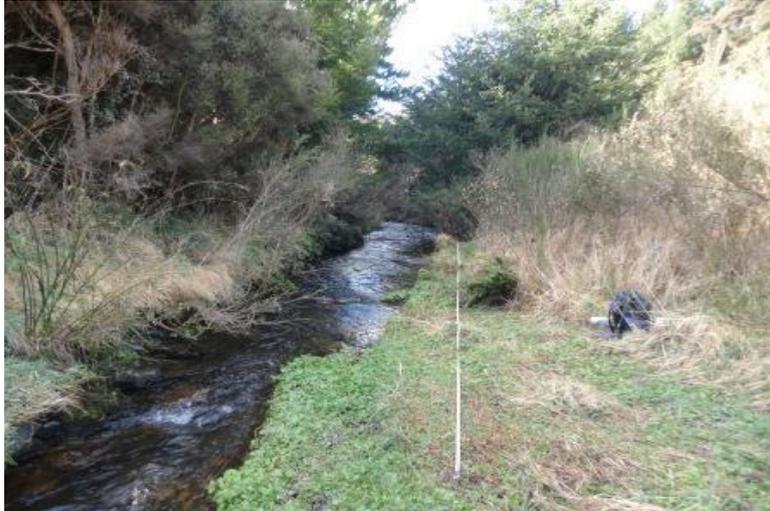
Site 5- Akatore, Centre Road:

Result: Overall score- **Good/Very good**

Summary: Not much change to the site compared to last year with presence of good native habitat and high invertebrate presence. True right of the stream is starting to get a bit overgrown with broom but can easily be fixed.

Conclusion: Recommend further monitoring

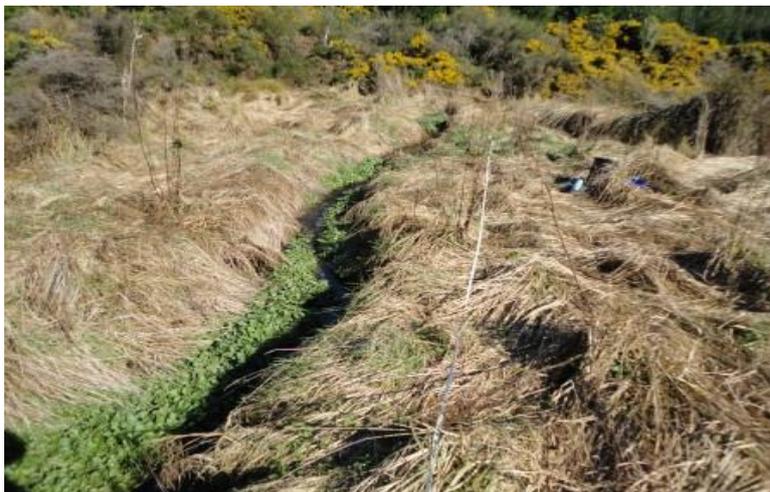
Site 6- Akatore, Narrowdales:

Result: Overall score: **Excellent**

Summary: The Akatore narrowdale site continues to provide very good scores in the SHMAK scoring system. It scores highly in habitat and invertebrate presence. The only problem was the high presence of water vegetation throughout the site and made for sampling difficult what was seen was a small fish possibly a glaxias which was positive to see. Periphytons were seen present through the site which also gives a high score.

Conclusion: Recommend further monitoring

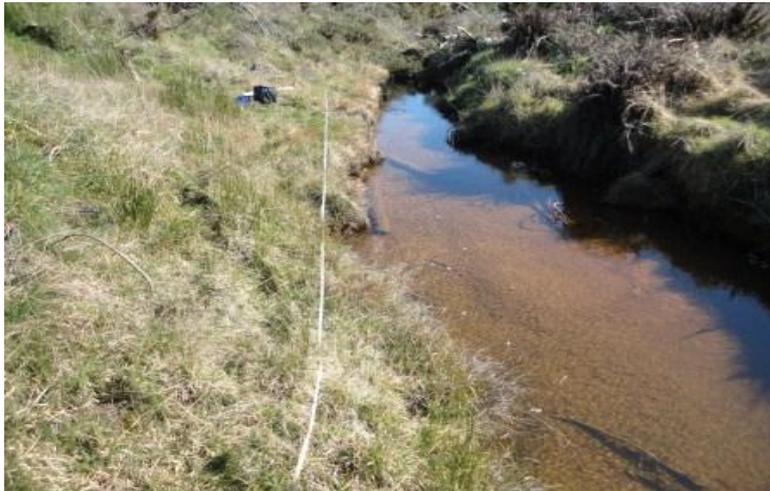
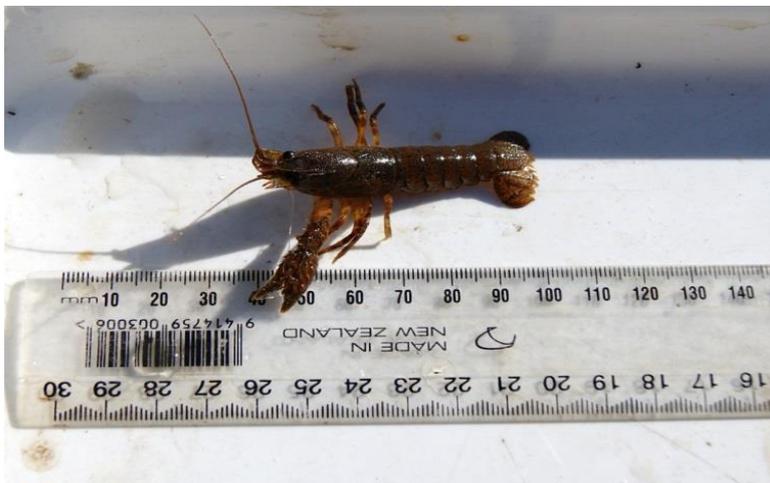
Site 7- Wangaloa, Wangaloa creek:

Result: Overall score- **Very Poor**

Summary: This was a test site from last year due to the fact that the previous site was difficult to access and wouldn't give an accurate result therefore the site was abandoned. This site is located in the middle of Wangaloa and would hopefully give better access and testing as it has recently been harvested a few years ago. Unfortunately the area gave a very poor result with very minor native vegetation, poor stream composition and very few invertebrate presence which was disappointing. However up to six koura (*Paranephrops zealandicus*) were found which would indicate a wider invertebrate presence throughout which is encouraging.

Conclusion: Recommend further monitoring
May look at an alternative site

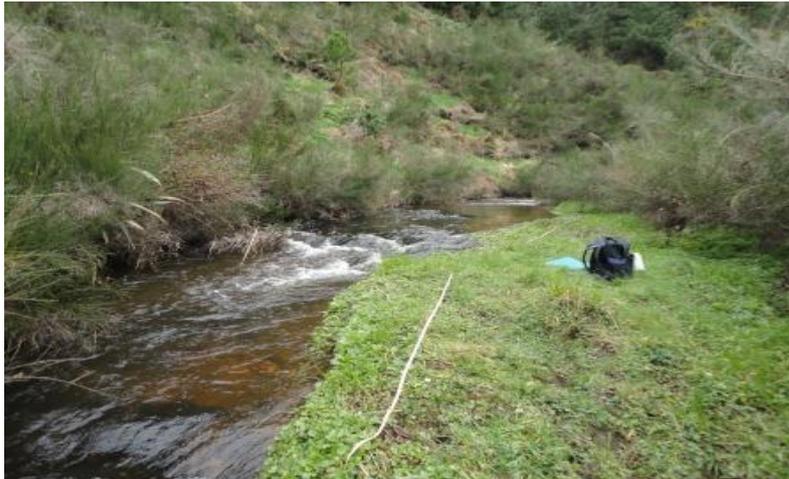
Site 8- Waitahuna, Bungtown stream:

Result: Overall score- Moderate

Summary: Bungtown stream didn't show much in comparison to last year in terms of habitat and condition of the stream. Last year's score was Good and drop in this year's score could have led to reduced signs of periphyton which was present throughout last year but only a small amount seen this year which

can contribute to the overall score. There had been some heavy rain in the area and flow was just beginning to stabilize which also could have been a factor. Overall the stream is in good condition.

- Recommend further monitoring
- Keep a good relationship with neighbour to provide access

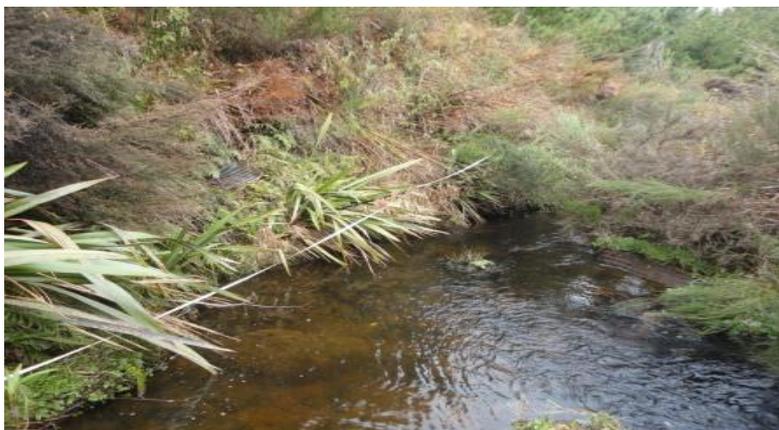
Site 9- Berwick, West Tokomariro Branch:

Result: Overall result: **Very Good**

Summary: The site scored highly for stream bed composition, vegetation and invertebrate presence. 2013 scored the stream as excellent and is still very good condition. Factors that contribute to this are very few deposits, native vegetation and fewer disturbances from harvesting and improved the quality of the stream.

Conclusion: Recommend further monitoring
Improve access to the SHMAK site

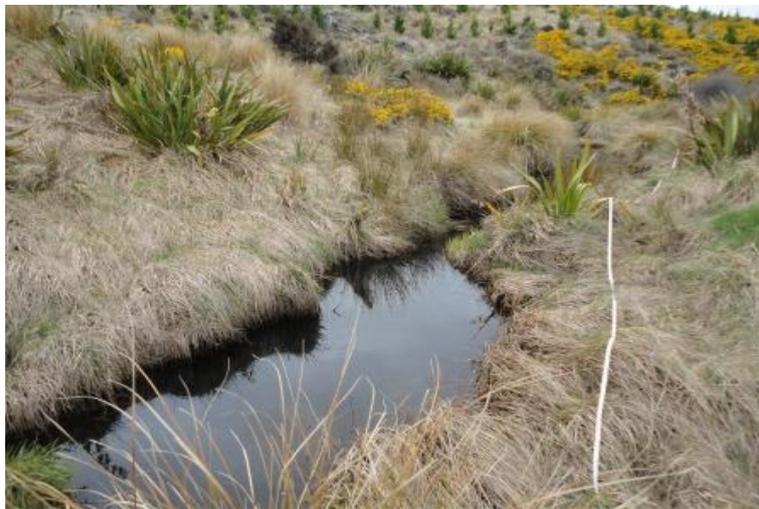
Site 10- Maungatua:

Result: Overall score- **Good**

Summary: This was a drop in last year's score going from an excellent to a good the reason possibly due to more increased pasture grasses and weeds, lack of stream flow that would have contributed to the reduced score. The stream bed composition felt very solid due to bedrock which can affect the score as well.

The deep slow moving nature of this stream made sampling testing at times and the narrowness and width of vegetation makes it prone to seasonal blockages which may affect monitoring scores. Due to the decrease of flow and ponding further downstream the site will be moved down stream where better flow is.

Conclusion: Recommended further monitoring

Move site downstream away from ponding as it has been suggested.

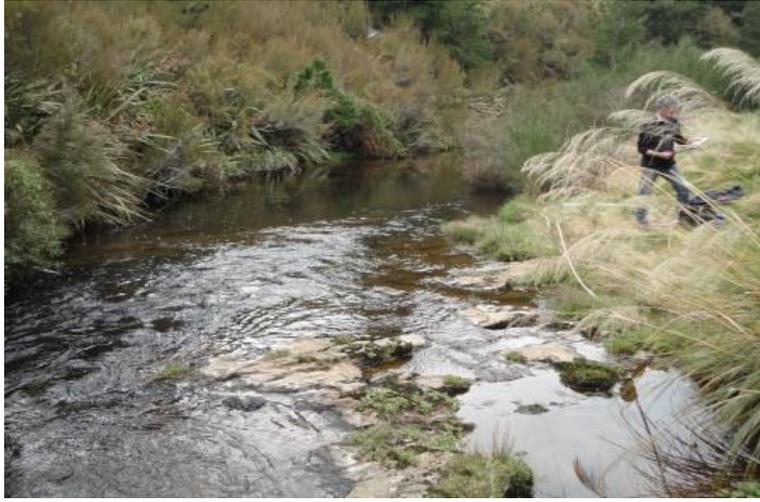
**Site 11- Berwick, Meggatburn**

Result: Overall score- **Good/Very Good**

Summary: The overall score was very good which was the same as last year's score. The site scored highly for stream bed composition, riparian vegetation and invertebrate presence. Periphyton presence was also noted in parts of the site. There was no real change in terms of condition of the stream and surrounding habitat. A small kora was observed as well.

Conclusion: Recommended further monitoring
